Skid Resistance – Important for Bike Safety

A. Niska, G. Blomqvist, M. Hjort

Swedish National Road and Transport Research Institute
VTI, SE-581 95 Linköping, Sweden
e-mail: anna.niska@vti.se; goran.blomqvist@vti.se; mattias.hjort@vti.se

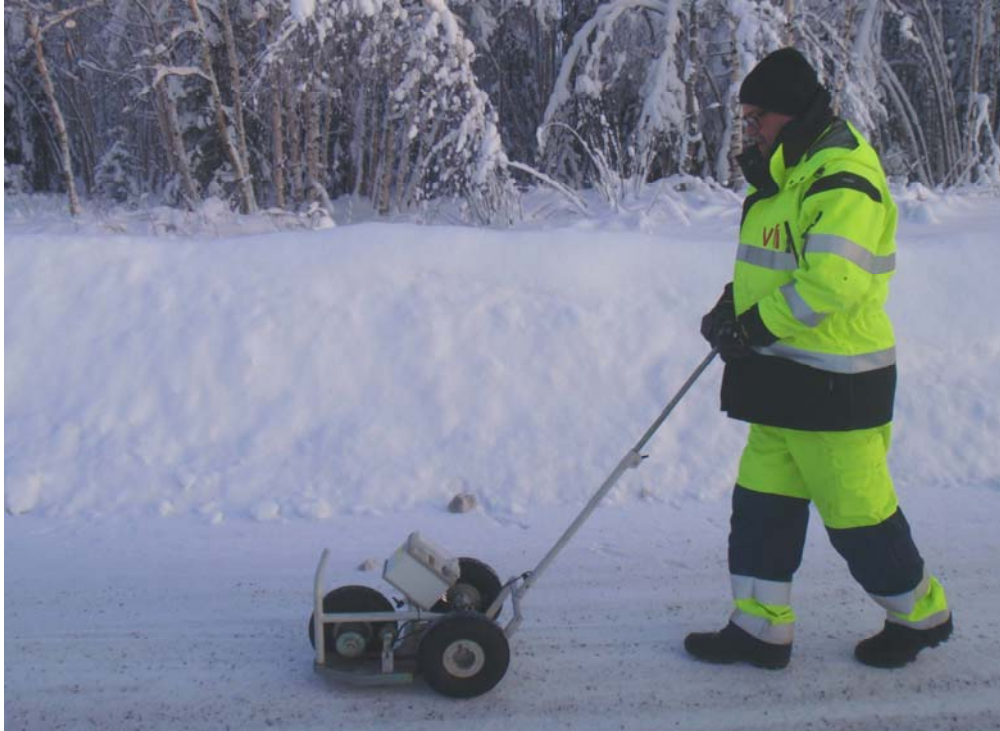
The PFT consist of a three-wheeled trolley with the measuring wheel mounted in front of the two support wheels (Figure 2). The rotation of the measuring wheel is set to a fixed slip of 20 per cent and is equipped with a smooth, standardised friction-measuring tyre, defined in American Society for Testing and Materials [12]. The friction between the measuring wheel and the surface of interest is presented as the friction coefficient, which is the frictional force on the measuring wheel divided by the normal load on the wheel. The minimum, maximum and mean friction of the surface measured is directly presented in an instrument display panel, but the measuring data can also be transferred to a PC for further analyses and presentation.

Figure 2. The Portable Friction Tester used to measure friction on cycleways.

When measuring friction on cycleways, we have used a portable, manually operated instrument, namely “the Portable Friction Tester” (PFT). The PFT was developed at VTI in the early 1980s and is used in research when measuring friction on small surfaces, down to 1 metre in length, where larger equipment is not applicable. It was originally designed to measure friction on road markings but has been proved to be a valuable tool for comparing friction measurements on cycleways [11].

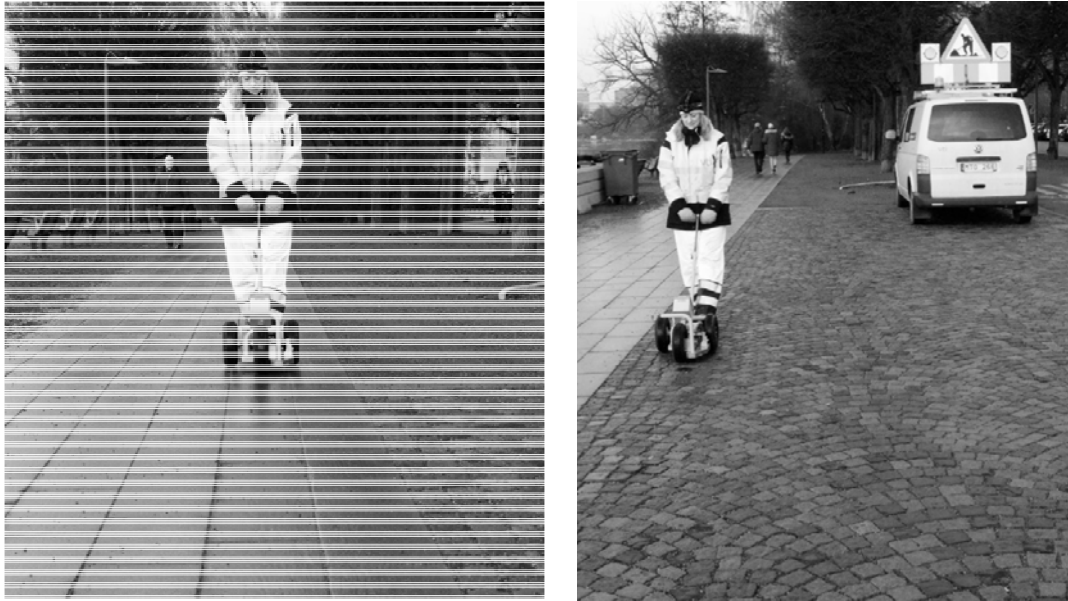
Figure 11. The concrete slabs (to the left) and the paving stones (to the right) measured in Stockholm in 2014.

Measurements in Stockholm (in February 2014) on different types of paving materials, shows that both concrete slabs and paving stones afford lower skid resistance than asphalt (Figures 10 and 11). At the time of the measurement the air temperature was -1°C and the road temperature varied from $+1$ to -3°C but there was no frost or ice on the surfaces. There was no difference in mean friction value between the concrete slabs and the paving stones – it was 0.66 for both surfaces compared to 0.91 for the asphalt surface. However, the variation in friction was greater for the paving stone representing a wider histogram in Figure 10.
